# Self-build amid rising temperatures: the case of Cantinho do Céu, São Paulo

## Abstract

This article, part of a broader study<sup>3</sup> investigating low-income housing, seeks to identify the key elements of the building envelope (walls, openings and roof) which compromise the thermal performance of self-built houses in the context of rising temperatures (a significant phenomenon in climate change). Based on a group of self-built houses located in *Cantinho do Céu*, an irregular settlement in the southern region of São Paulo city, an evaluation method was applied combining analysis of the housing enclosures with field research, interviews and thermographic photography.

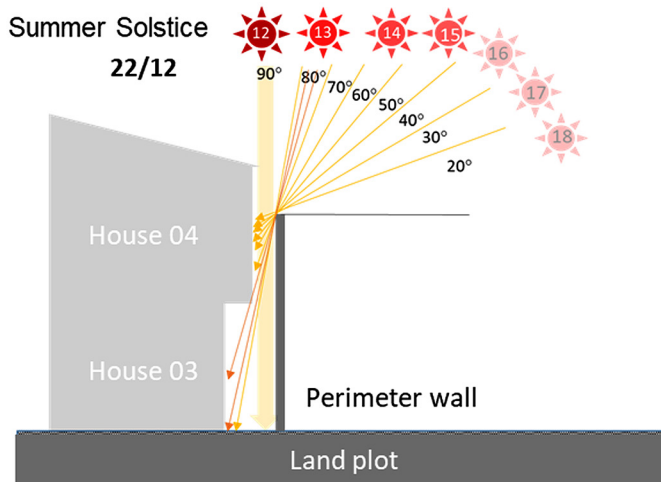
Figure 2 – Schematic cross-section of houses 3 and 4, and angles for height of sun during summer solstice

Legend: position of houses and plot perimeter wall restricts solar radiation incidence during summer solstice (22/12), date present in solar graph from LabEE, used as reference for calculating angles between 12:00 and 18:00 hours.

Figure 3 and 4 present solar graphs for houses 3 and 4, respectively. The green area represents the shading of the façade that incorporated 4 openings (living room, kitchen, bathroom and bedroom) of house 3, and the two openings (living room/kitchen and bedroom) of house 4. The

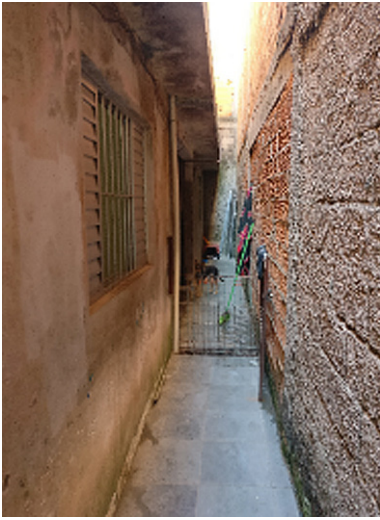
Figure 5 – House 7,  
uncovered side corridor

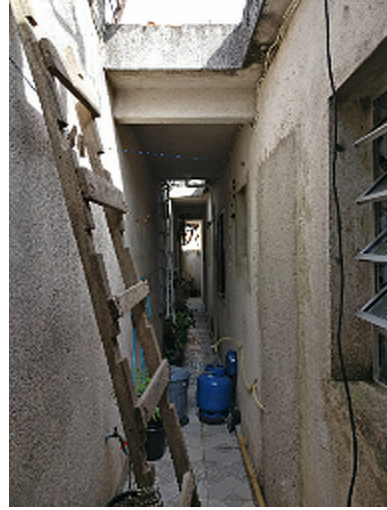
Figure 6 – House 9,  
partially-covered narrow side corridor

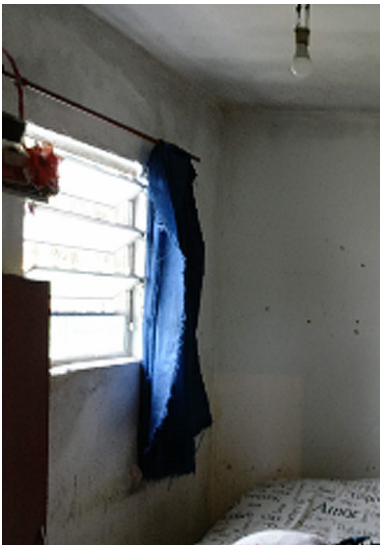
Figure 7 – House 22,  
undersized window for bedroom

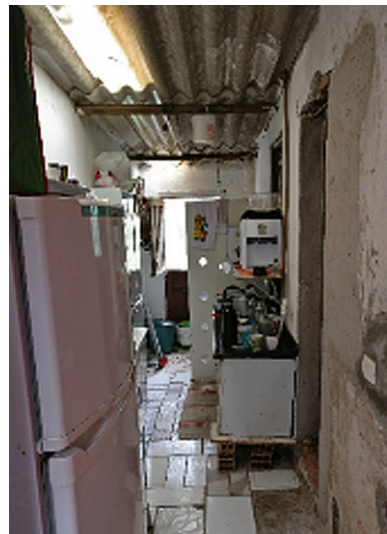
Figure 8 – House 22,  
lack of space led to side corridor being  
turned into kitchen and service utility area

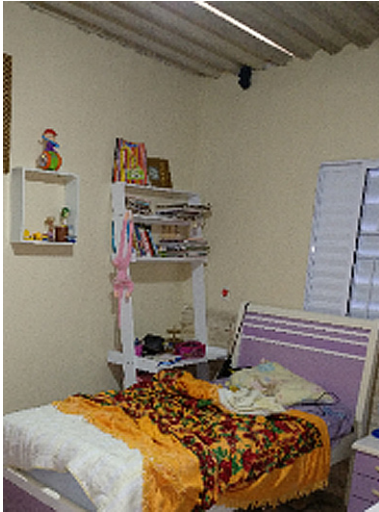
Figure 9 – House 18,  
visible light gap between fiber-cement  
sheeting after house extension

than recommended rake of the sheets, together with poorly installed material (visible gap between sheets), caused leaks. In Figure 10, the mold remained even after addition of the second floor.

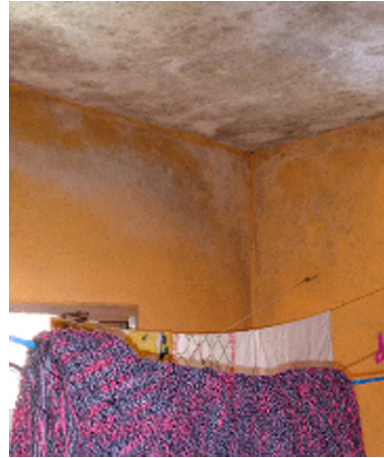
Figure 10 – House 18,  
mold on walls and ceiling remain  
even after addition of second floor

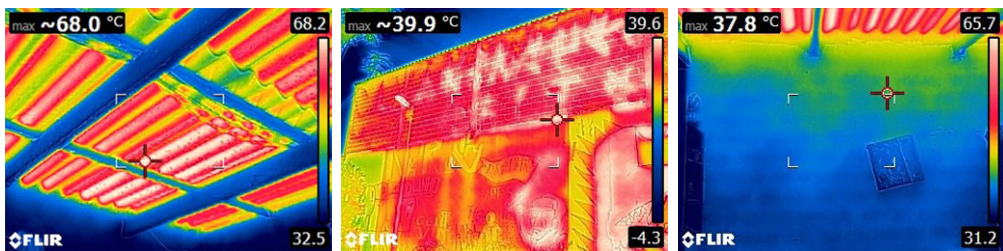
Figure 11 – Set of thermographic photos of house 4

On the 3rd of April 2019, for example, thermographic image of house 4 were produced (Figure 11). The outside temperature of the air between 12:50am and 1.45pm, was approximately 28°C and moisture level 43%, whereas the temperature of the surface of the shingles reached around 68°C (Figure 14), in parts of the roof, while temperature of the internal wall reached 37.8°C. The thermal lag of the fiber-cement shingles was 0.2 hours, i.e. the material began to irradiate heat into the house within 12 minutes.

Legend: the roof reached 68°C, the outside façade had a maximum temperature of 39.9°C, while the corresponding internal wall reached 37.8°C.
